Feasibility Report for Ponderosa Woods Stream Restoration Project—FINAL

Plymouth, Minnesota

Prepared for
Bassett Creek Watershed Management Commission

June 2023

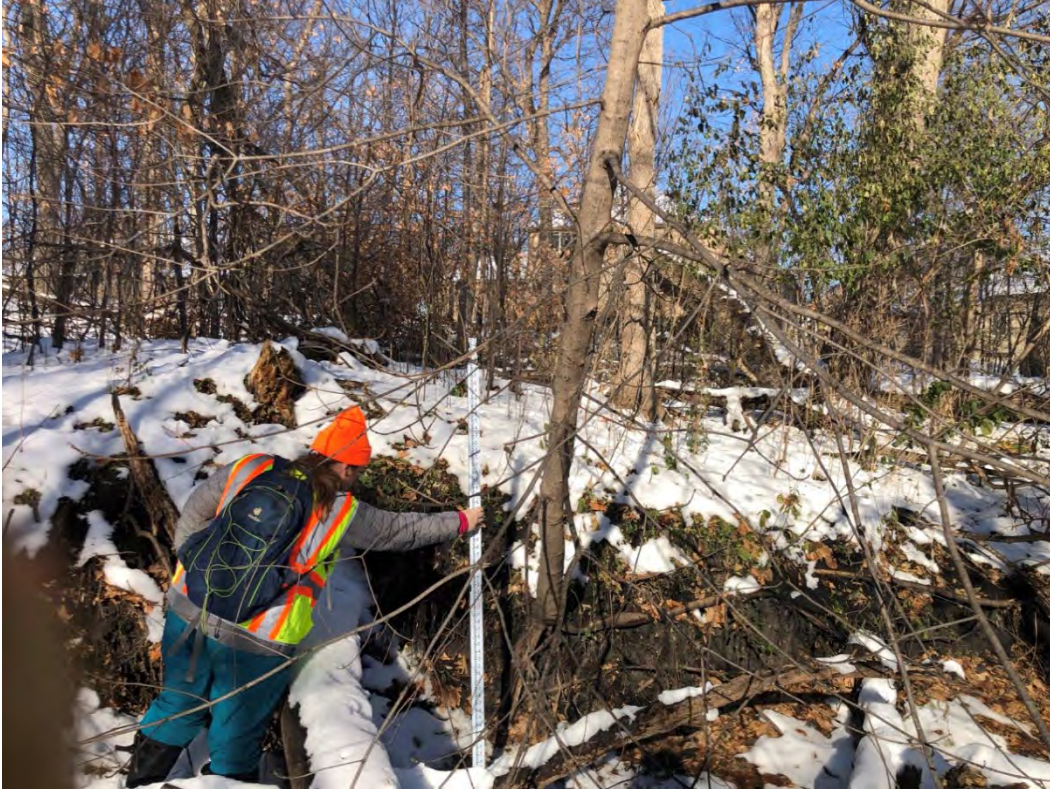
Figure A- 3 *Left bank erosion.*

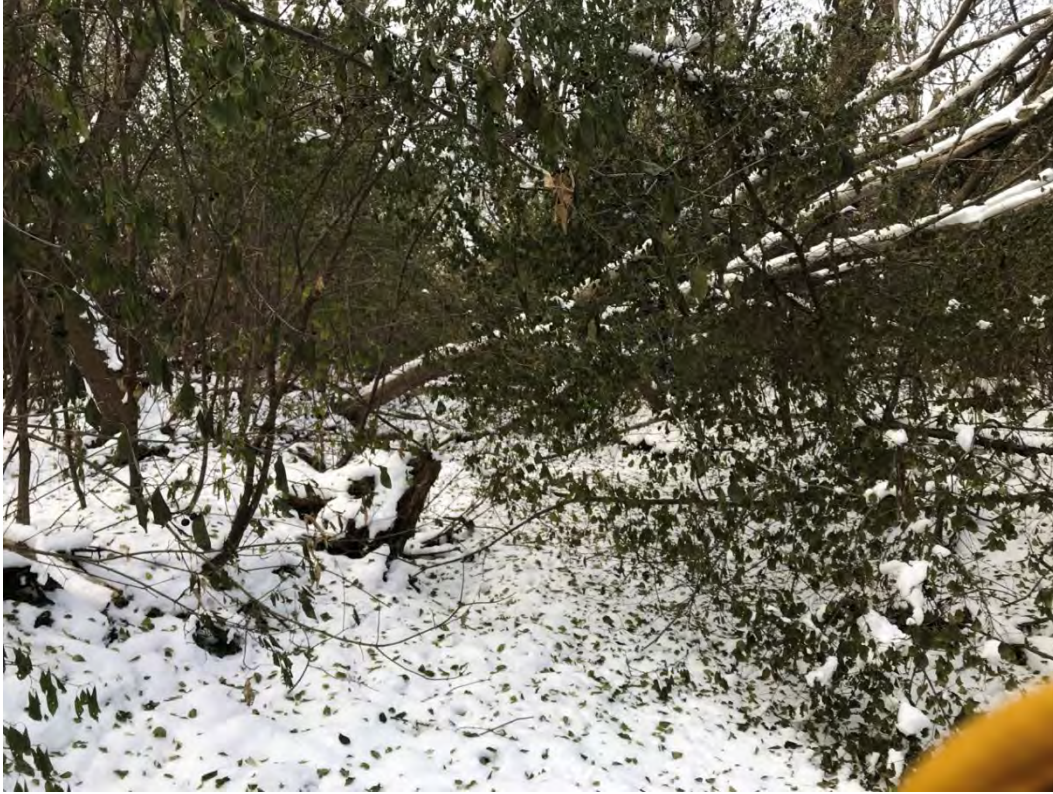
Figure A- 21 *In-channel debris leading to bank erosion and sediment aggradation.*

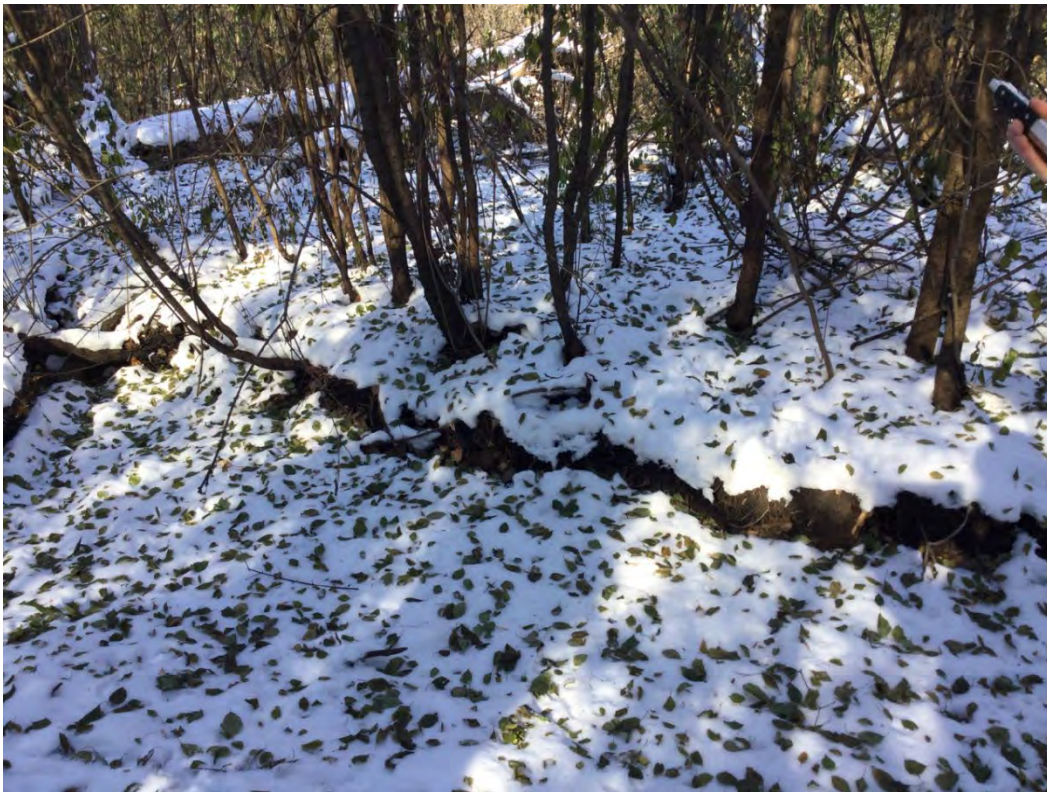
Figure A- 24 *Left bank erosion with undercutting.*

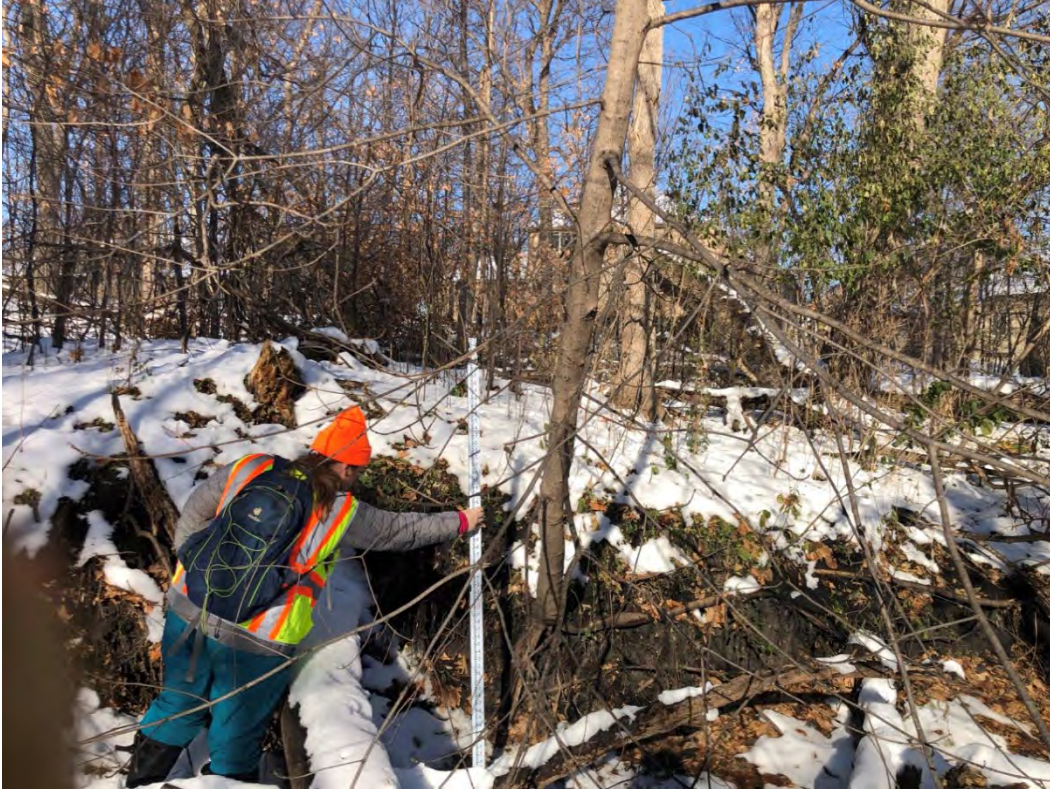
Figure A- 3 *Left bank erosion.*

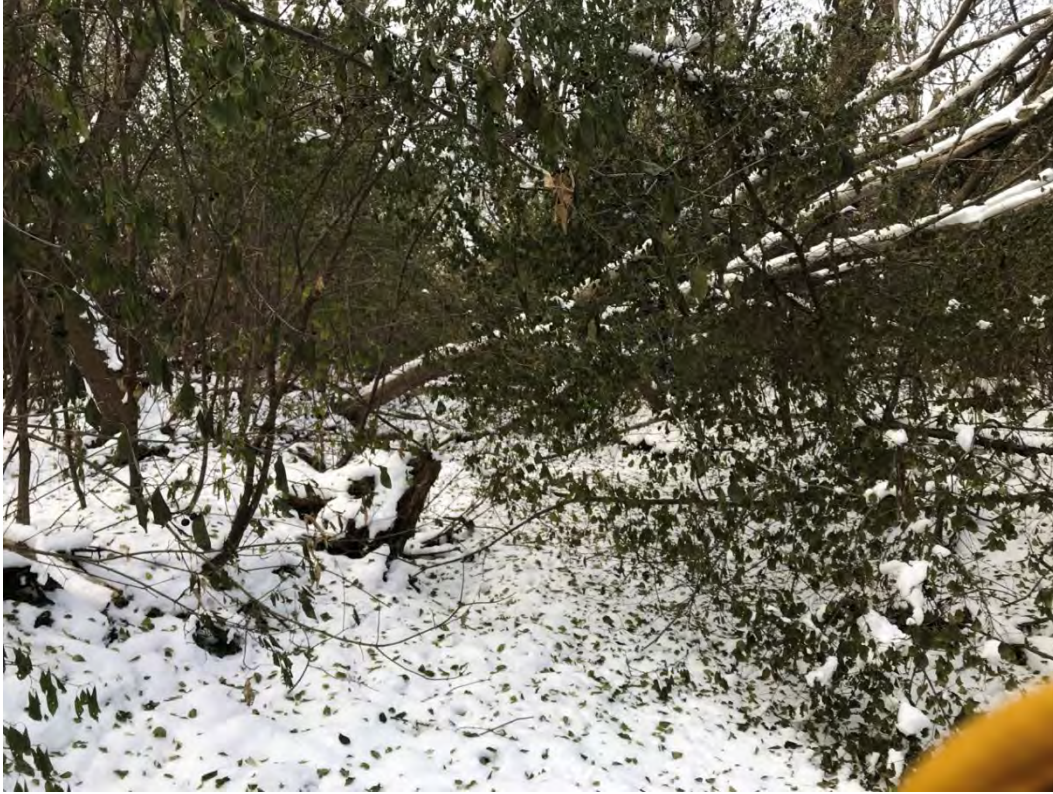
Figure A- 21 *In-channel debris leading to bank erosion and sediment aggradation.*

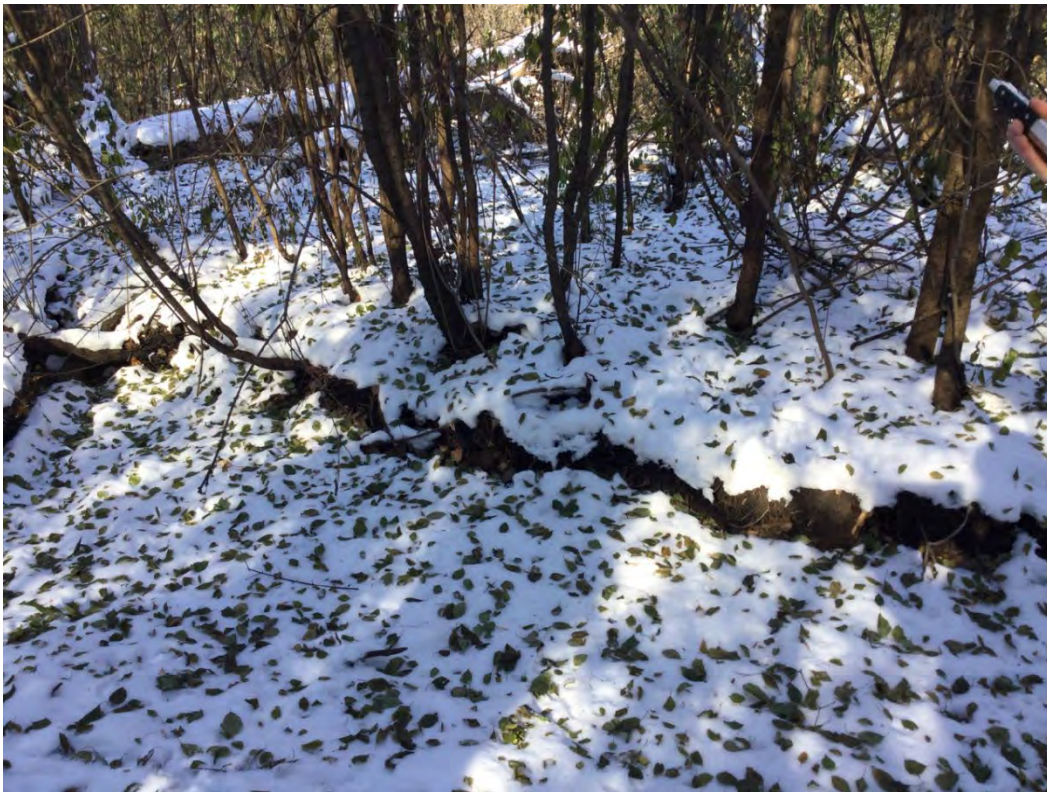
Figure A- 24 *Left bank erosion with undercutting.*
