Aquatic Plant Point-Intercept Survey for Schmidt Lake, Plymouth, Minnesota, 2017

Aquatic Plant Point-Intercept Survey: May 23, 2017
Eurasian Watermilfoil Delineation: May 23, 2017

Prepared for:
Schmidt Lake Association
Plymouth, Minnesota

Prepared by:
Steve McComas
Jo Stuckert
Connor McComas
Blue Water Science
St. Paul, MN 55116

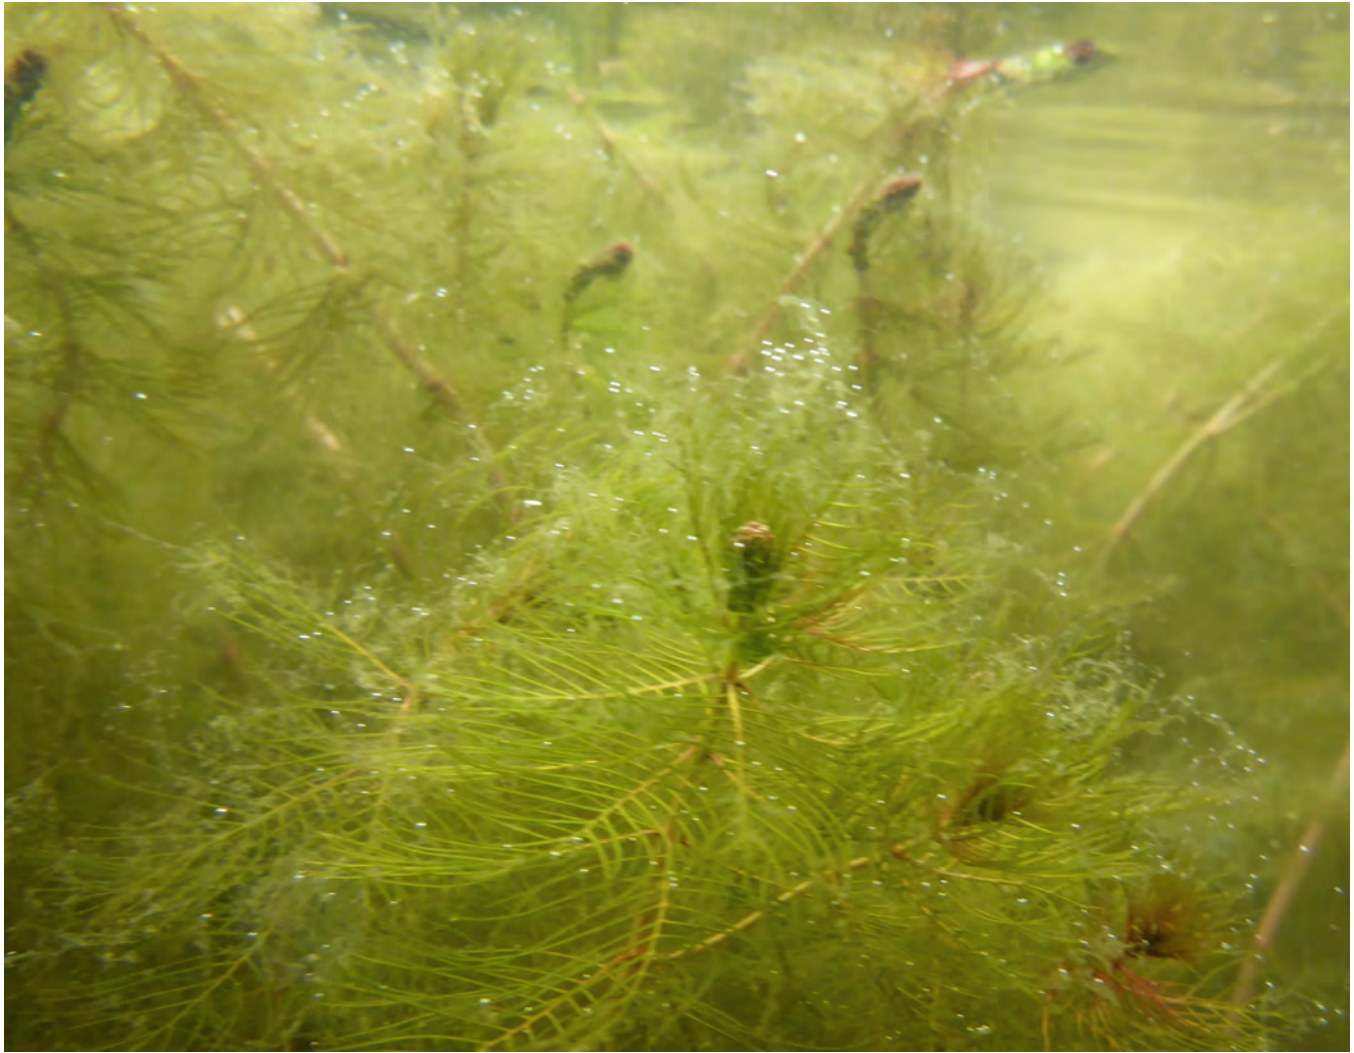
Underwater View of Eurasian Watermilfoil in Schmidt Lake on May 23, 2017

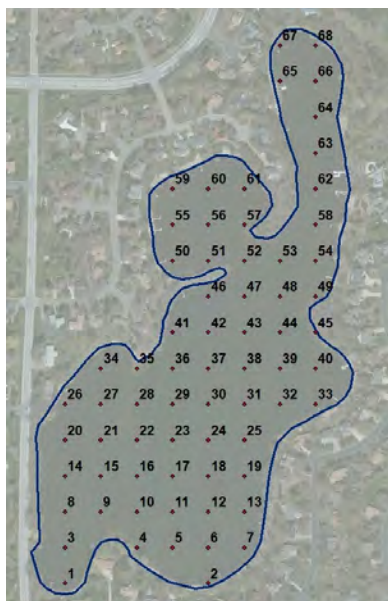
Figure 1. Point locations for the aquatic plant surveys. Lake map with UTM coordinates using the WGS84 datum.

An aquatic plant survey of Schmidt Lake using a point intercept sampling method was conducted by Blue Water Science on May 23, 2017. A map and sampling grid were prepared by Blue Water Science and a consisted of a total of 68 points that were distributed throughout the 45 acre lake (34 acre littoral zone)(Figure 2). Points were spaced 50 meters apart and each point represented an average of 0.67 acres of lake surface area.

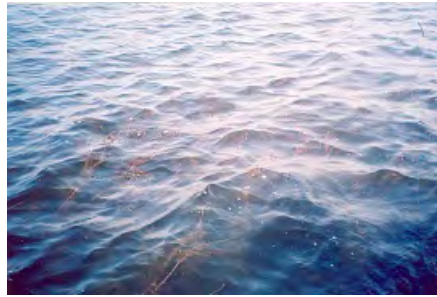
Light Growth Conditions

Plants rarely reach the surface.

Plants are in scattered patches*.

Navigation and recreational activities generally are not hindered.

Stem density: 1 - 90 stems/m²

Biomass: 0 - 70 g-dry wt/m²

MnDNR rake sample density equivalent for light growth conditions: 1 or 2.

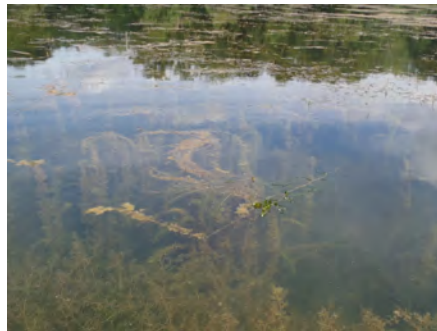
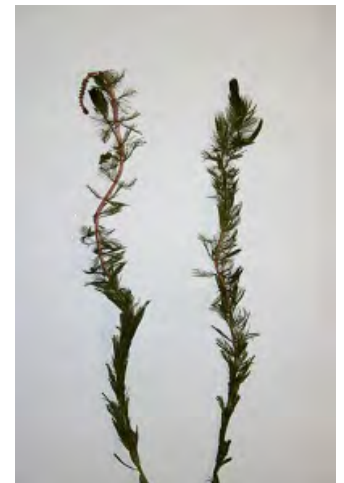
Moderate Growth Conditions

Broken surface canopy conditions. However, stems are usually unbranched.

Plants are in beds* with some patches.

Navigation and recreational activities may be hindered.

Lake users may opt for control.

Stem density: 90 - 180 stems/m²

Biomass: 70 - 200 g-dry wt/m²

MnDNR rake sample density equivalent for moderate growth conditions: 3.

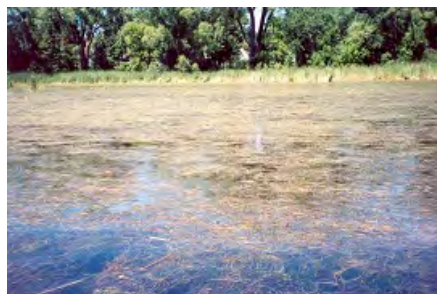
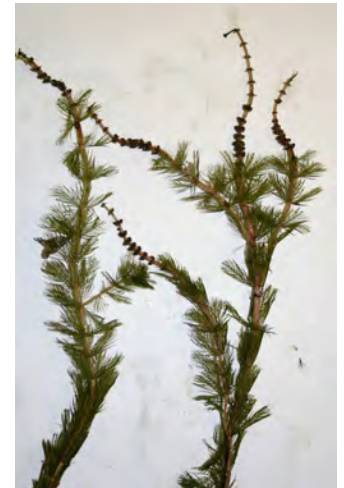
Heavy Growth Conditions

Solid or near solid surface canopy conditions. Stems typically are branched near the surface.

Plants grow in continuous beds.

Navigation and recreational activities are limited.

Control is necessary for navigation and/or recreation.

Stem density: 180+ stems/m²

Biomass: >200 g-dry wt/m²

MnDNR rake sample density equivalent for heavy growth conditions: 4.

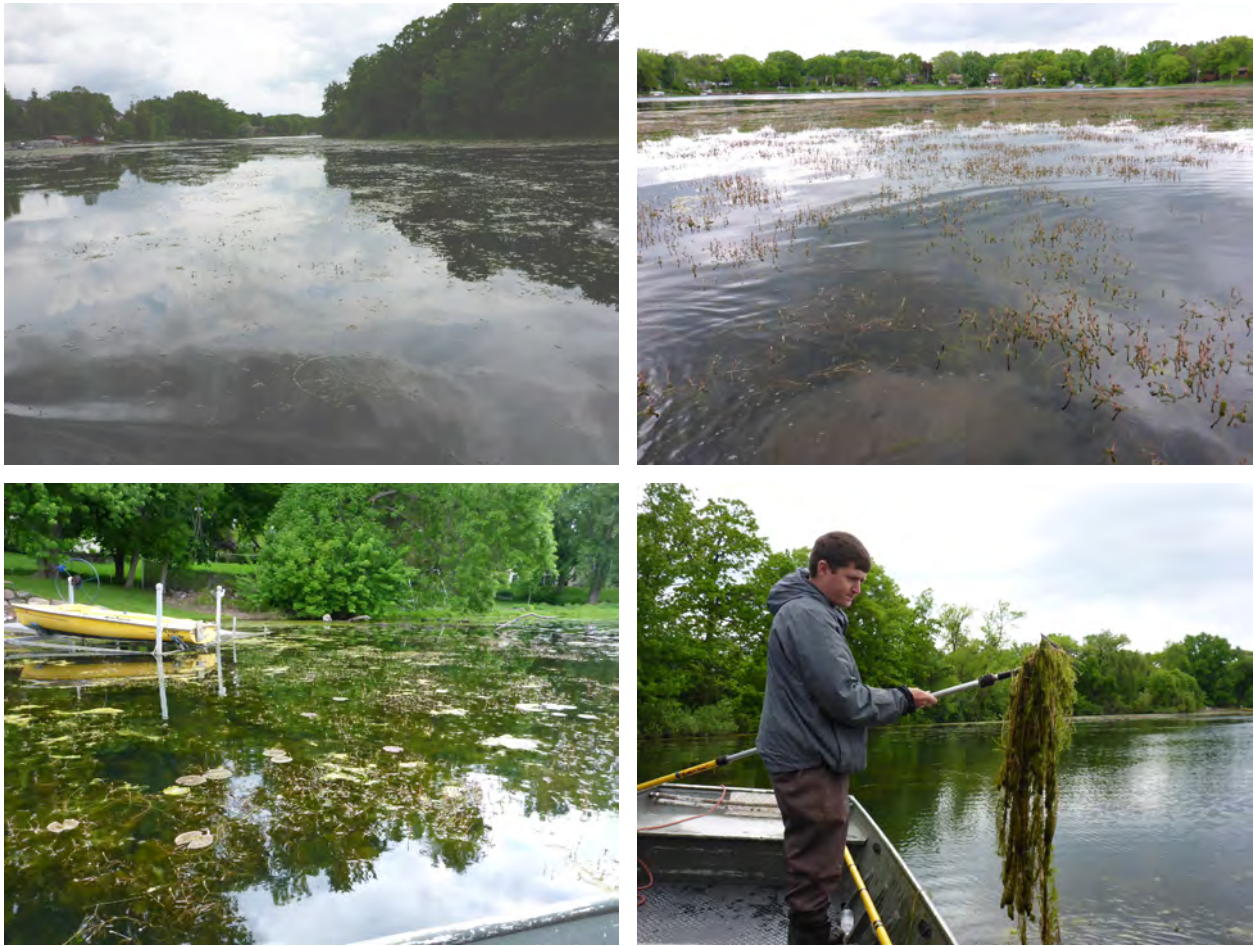
Aquatic Plant Conditions in Schmidt Lake on May 23, 2017: Hybrid milfoil (cross between Eurasian and northern watermilfoil) was the dominant milfoil and was widespread in Schmidt Lake.

Figure 5. Lake conditions on May 23, 2017.

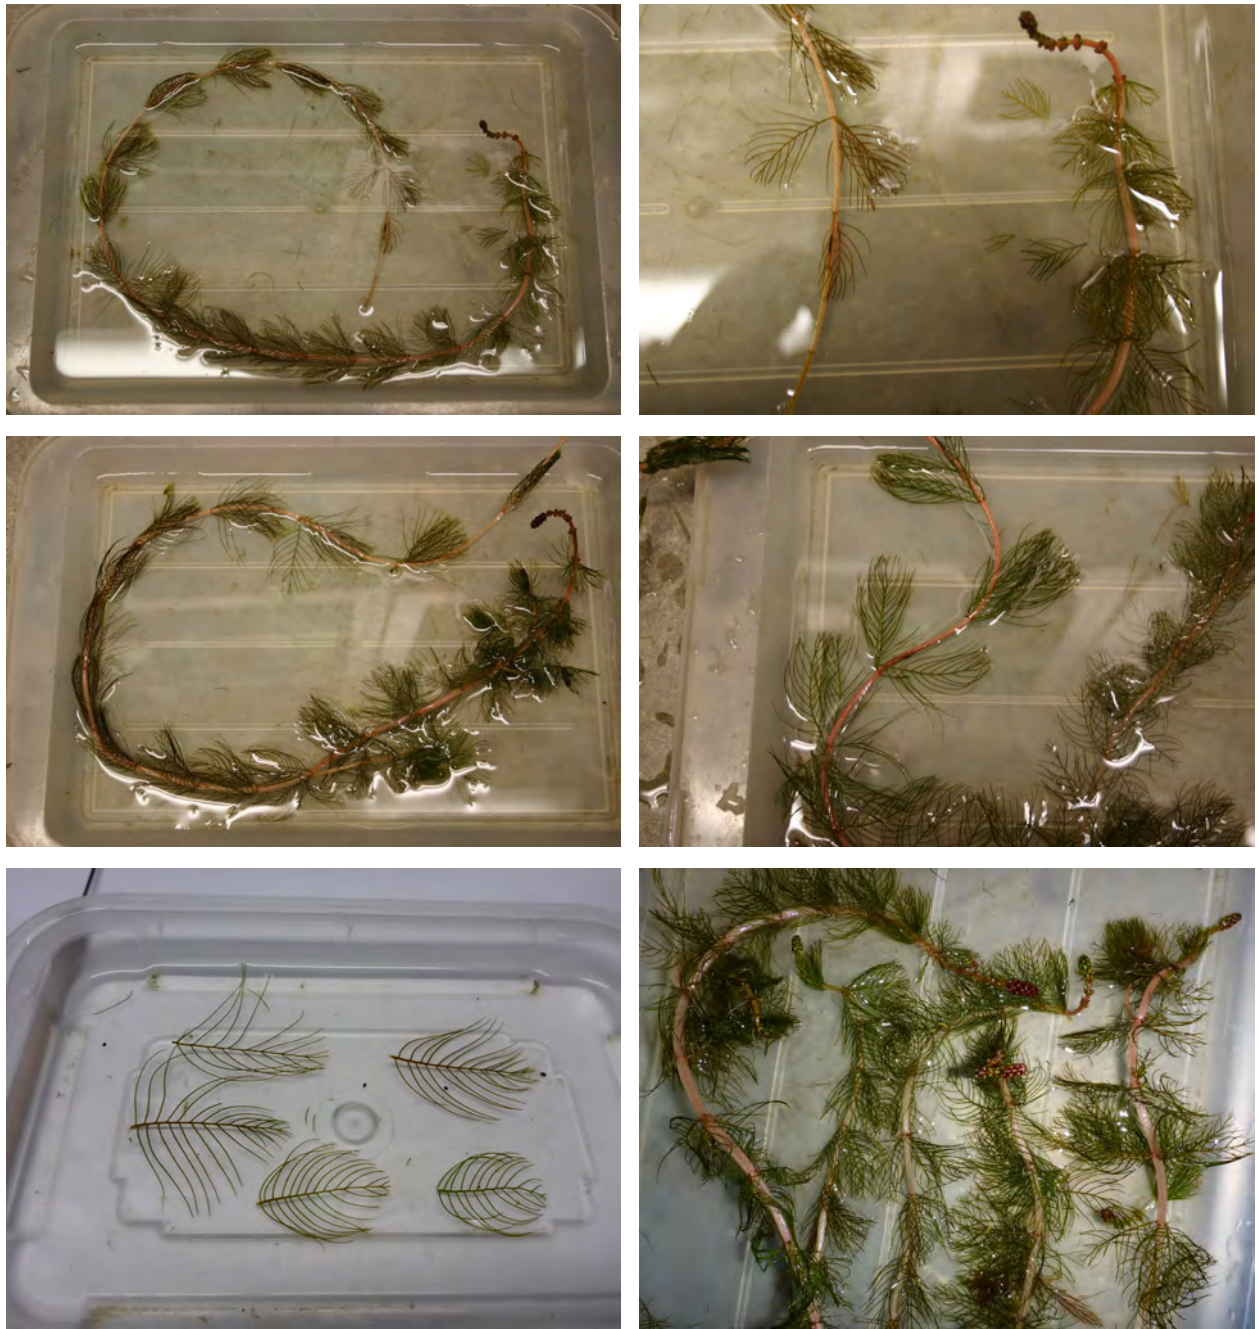
Figure 6. Hybrid Eurasian watermilfoil from May 23, 2017. These pictures were taken in the lab.
