Feasibility Report for Ponderosa Woods Stream Restoration Project—FINAL

Plymouth, Minnesota

Prepared for
Bassett Creek Watershed Management Commission

June 2023

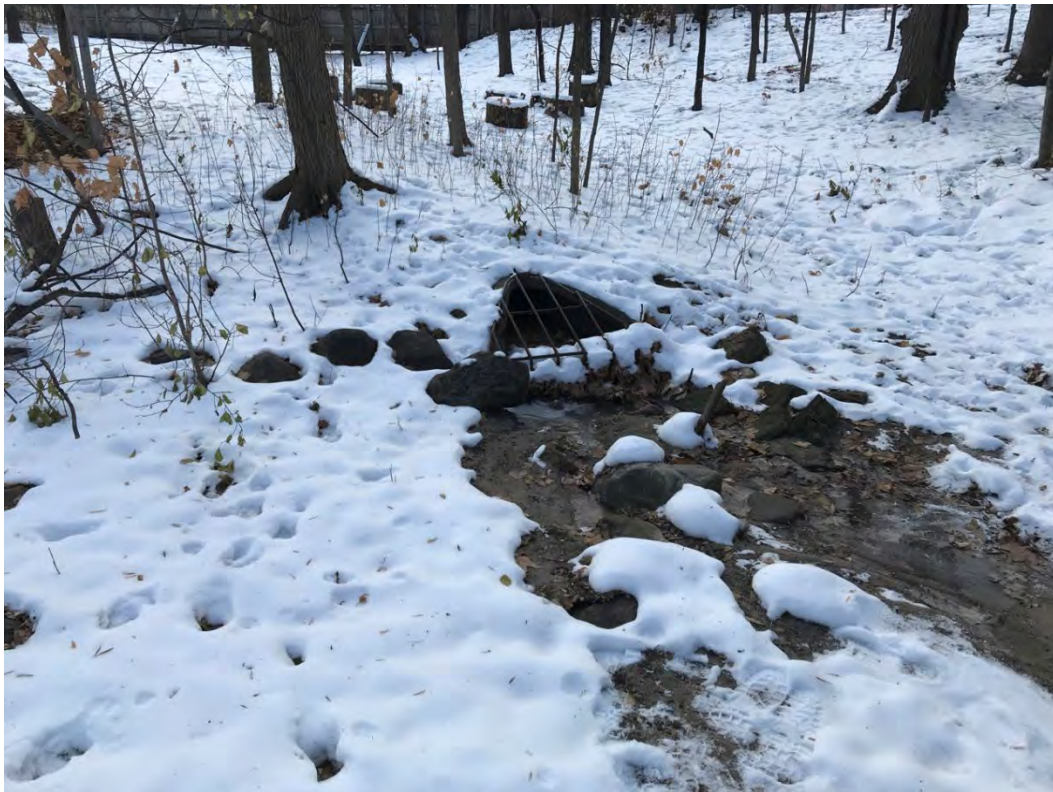
Figure A- 14 *Upstream end of southwest stormwater side-channel.*
