Feasibility Report for Ponderosa Woods Stream Restoration Project—FINAL

Plymouth, Minnesota

Prepared for
Bassett Creek Watershed Management Commission

June 2023

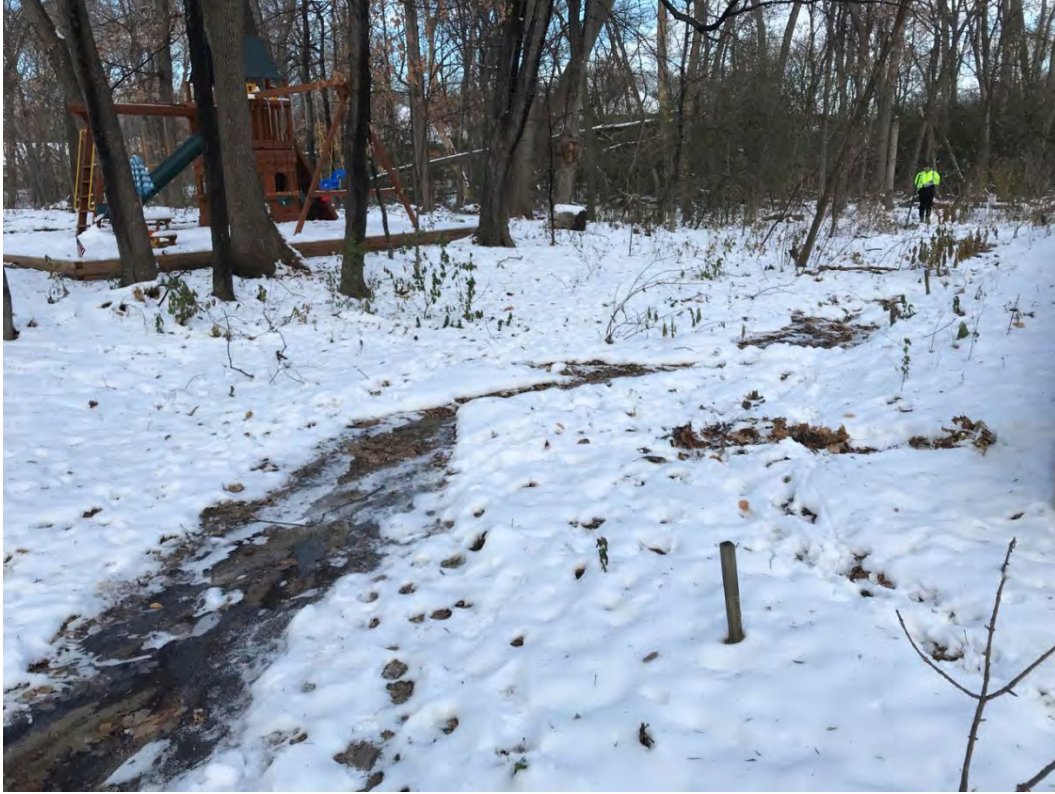
Figure A- 15 *Southwest stormwater side-channel looking downstream.*

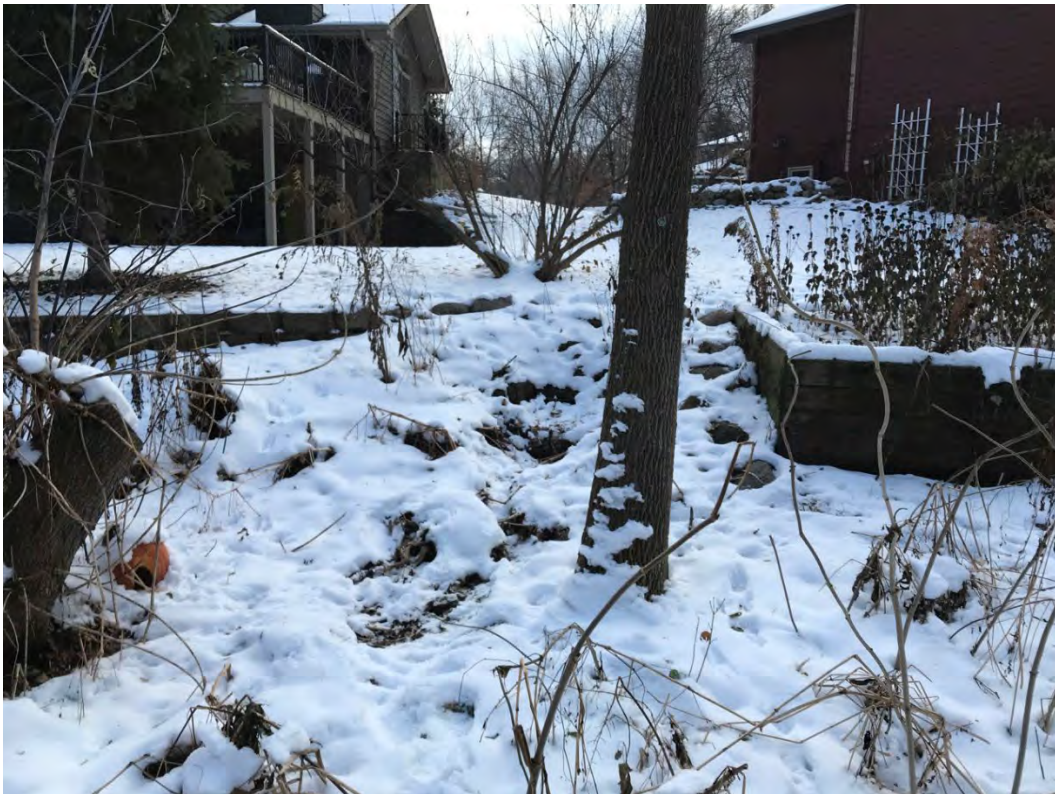
Figure A- 16 *Upstream end of southeast stormwater side-channel.*

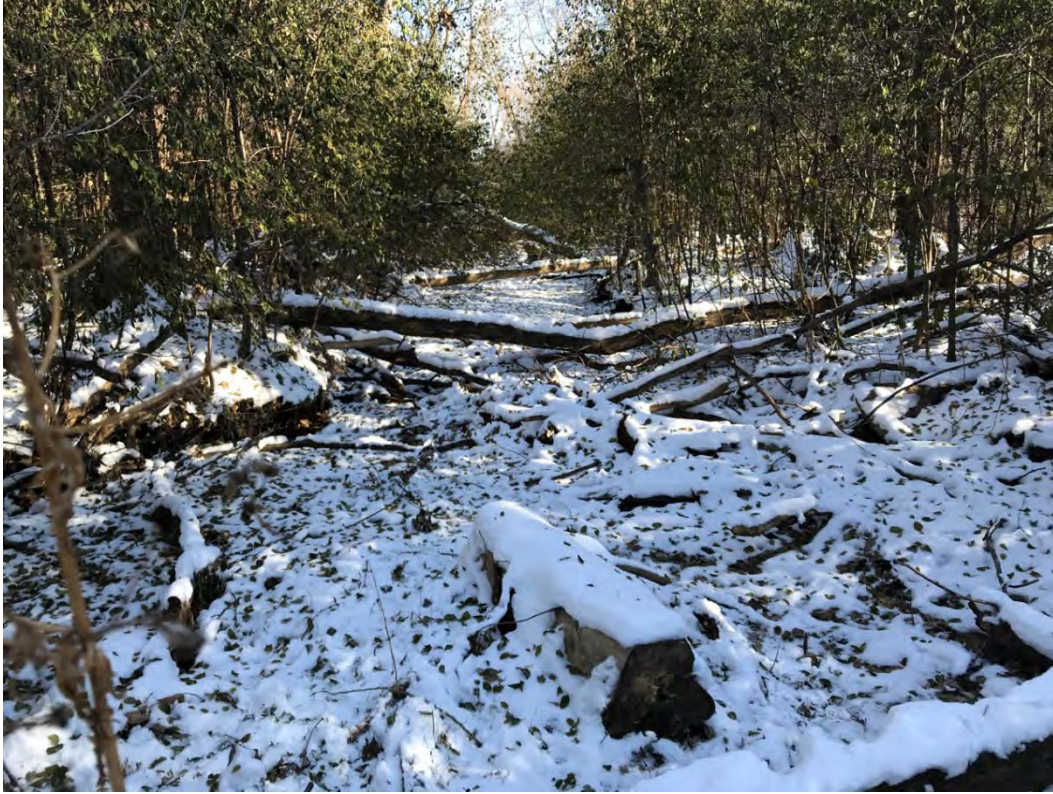
Figure A- 13 *In-channel (same location but different angle as figure above).*
